## Appendix H - AAI December 8, 2006, Report

## Crandall Canyon Mine Ground Condition Review for Mining in the Main West North Barrier

December 8, 2006

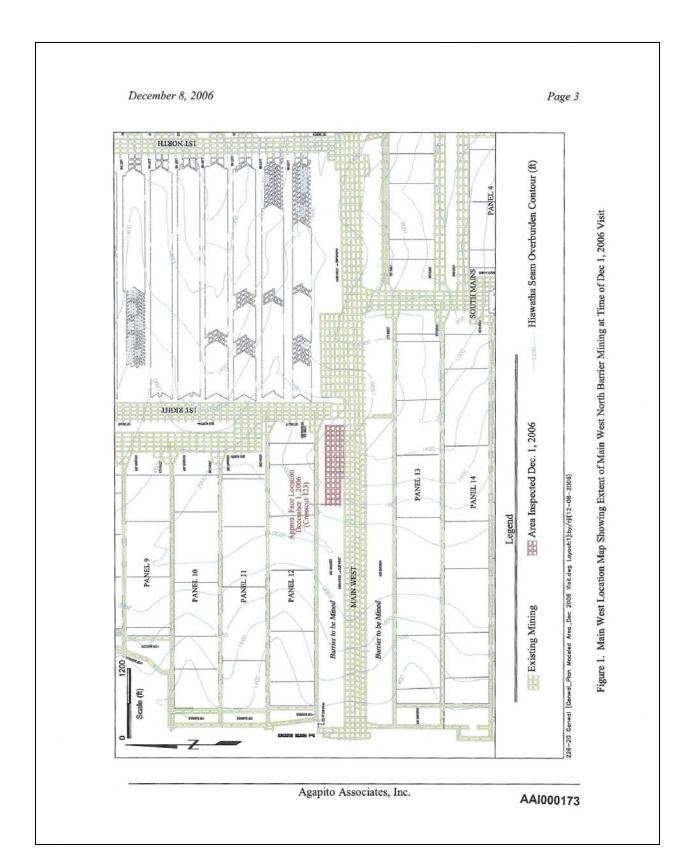
At the time of our visit, four entries with 60-ft by 72-ft (rib-to-rib) pillars were developed in the Main West north barrier to Crosscut 123, where the depth of cover was almost 2,000 ft (See Figure 1). Entry widths were cut at 17 ft and were about 20 ft wide at pillar mid-height. Roof support included systematic bolting and rib-to-rib meshing. To the north and south of the mining area, 130-ft and 60-ft barriers were left, respectively, for the purpose of protection.

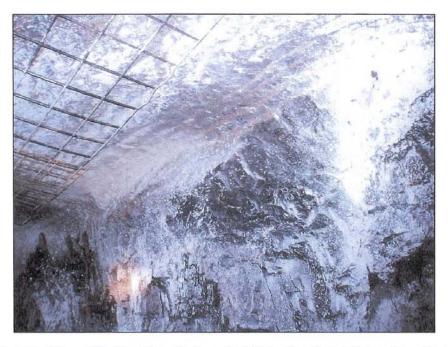
West Main barrier. Photo 1 shows only minor rib sloughing at Crosscut 123 in the entry immediately north of the West Mains. Photo 2 shows the second entry below longwall Panel 12 with minor sloughing at the rib between Crosscut 122 and Crosscut 121. The conditions of ribs along the north remnant barriers were good and consistent as shown in Photo 3. The rib was mildly yielded, but showed no evidence of blowouts, indicating that the 130-ft-wide remnant barrier pillar is wide enough to accommodate the load transfer from Panel 12 for short-term mining. The abutment load is expected to have alleviated since the time that Panel 12 was retreated in 1999 due to ground settlement and subsidence.

Photo 2. Minor Rib Sloughing at Crosscut 122 in the Second Entry from North Remnant Pillar

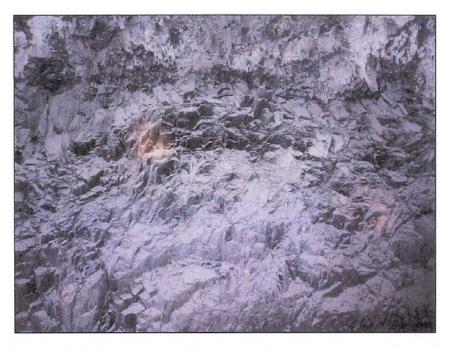
Photo 3. North Remnant Barrier Pillar Rib Condition Between Crosscuts 120 and 119
